Inspector's Daily Report

IDR Sheet	1	of	3	Sheets
Contract	Day				Date
C7852	Wednesday				June 8, 2011

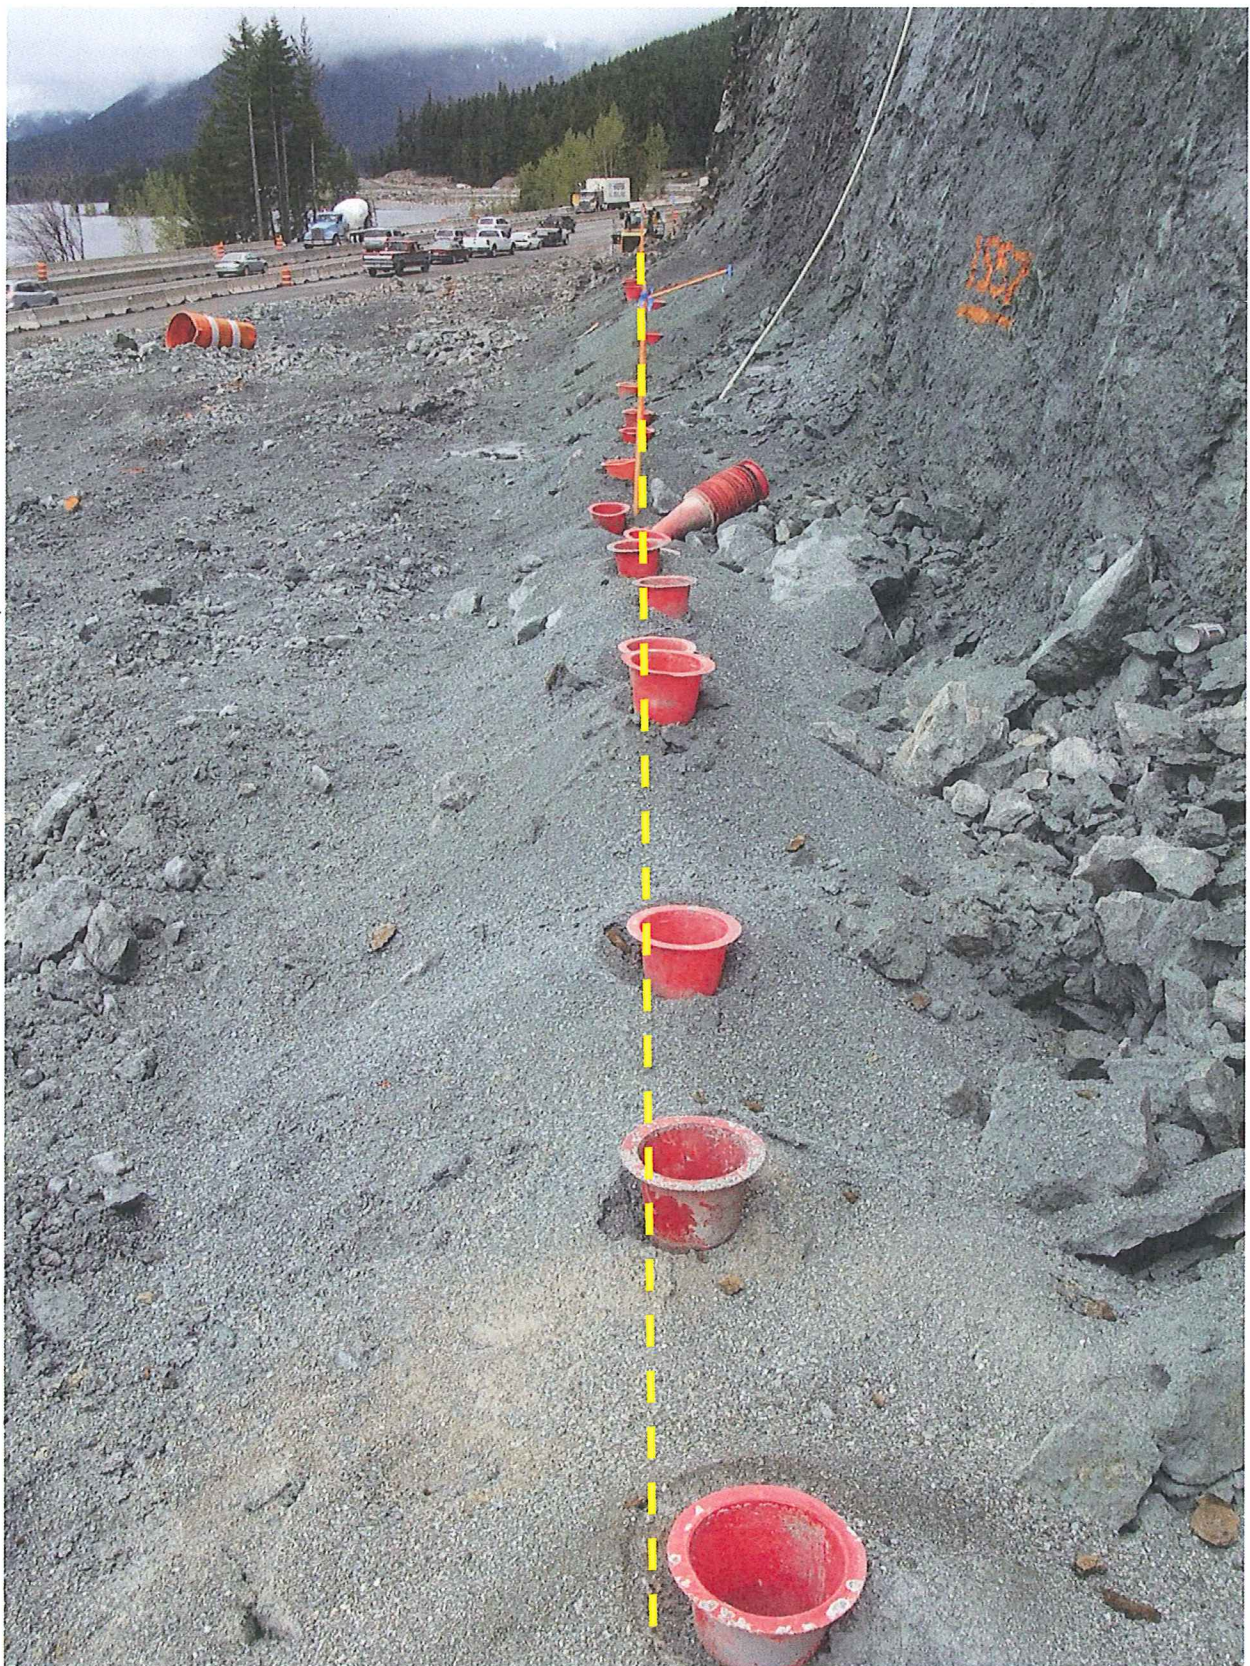
I went out to the construction site with Mike Mulhern and Eric Smith (WSDOT Geotechnical Inspector) at 12:30 pm to find Jerry Dilley already on-site and talking with Brandon Bair. As we were walking up to the recently excavated section, Jerry Dilley and I noticed that they had drilled a preshear drill line from approximately LW Station 1326+00 to 1327+00. As you can see in Figure 1, there is still room for improvement in drilling straight preshear lines; however, this is a dramatic improvement from the previous season.

Figure 1. A photo of the line drilling for the preshear blast between approximately LW Station 1326+00 and 1327+00. The yellow dashed line is the surveyed preshear alignment.

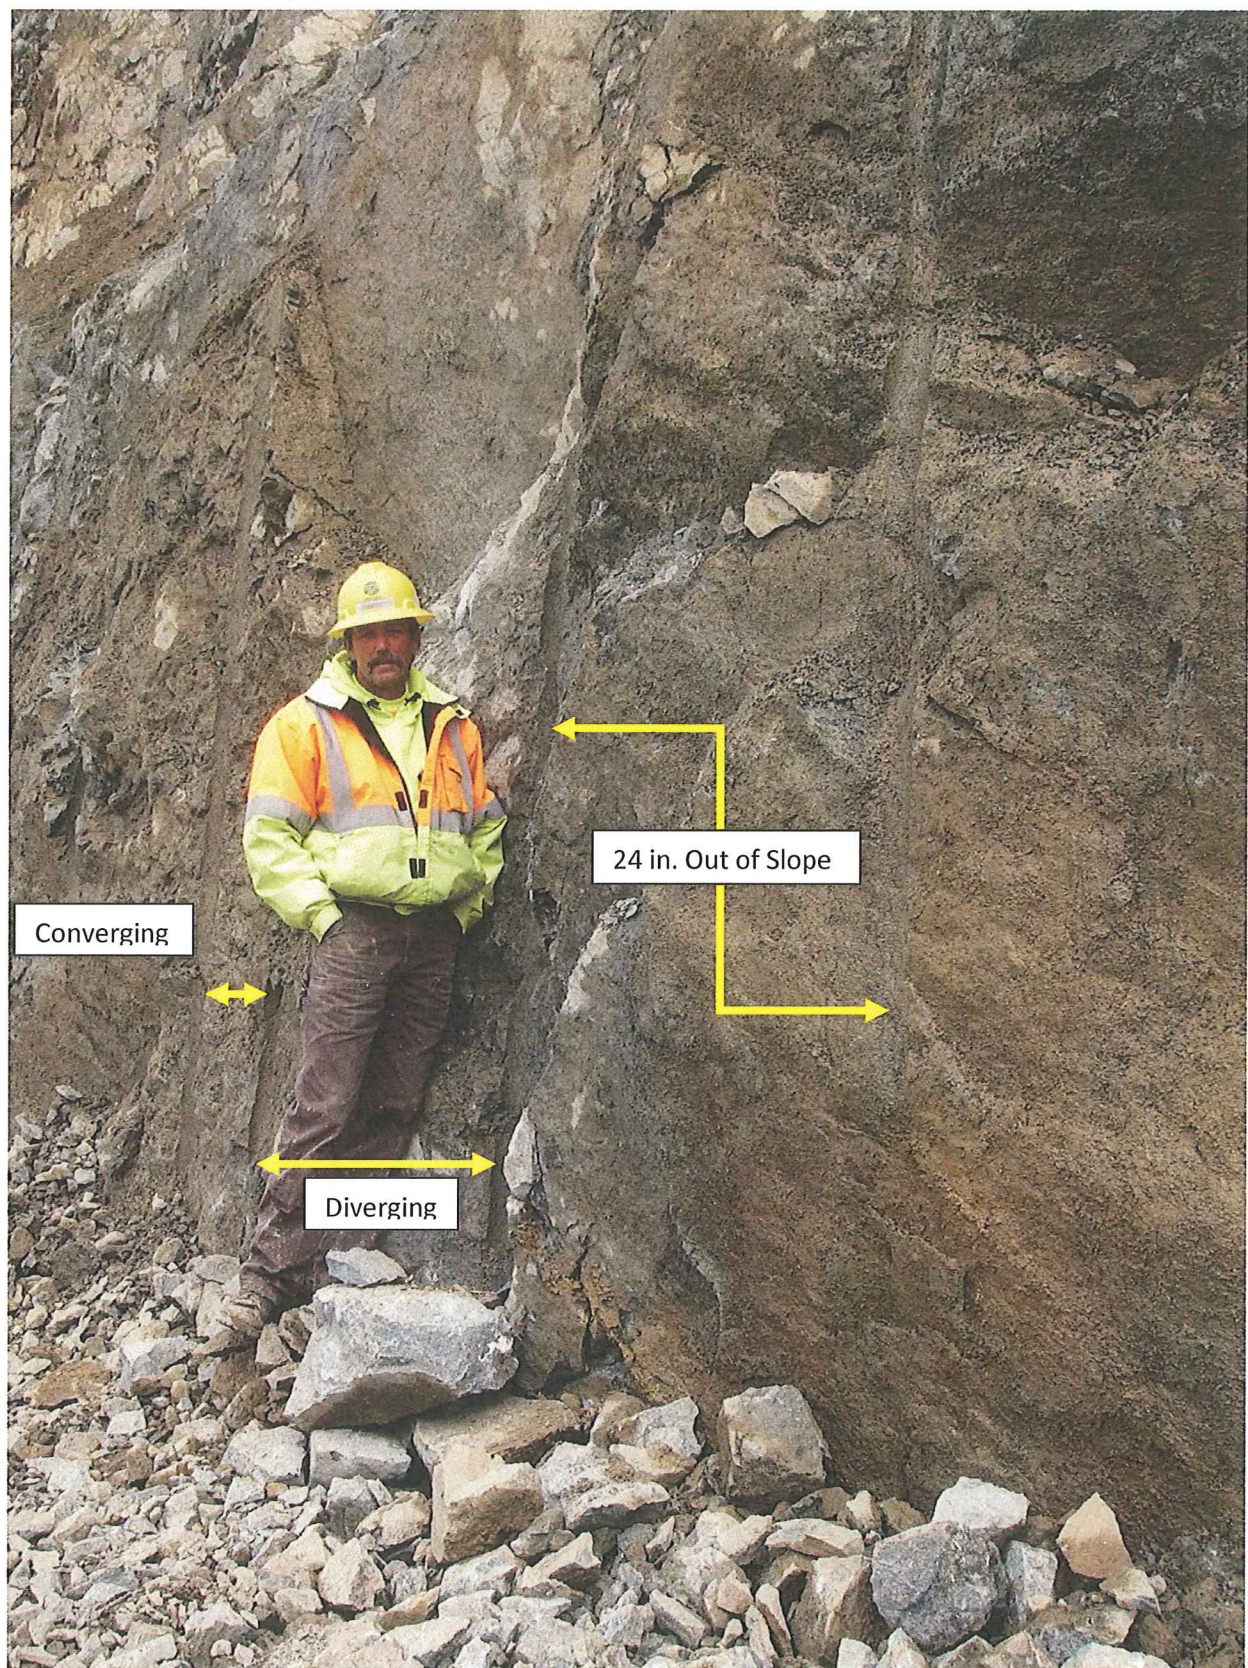
We walked up to the recently excavated section that appeared to be between LW Station 1328+85 and 1329+50. The excavation ranged from about 15 to 12 feet deep from north to south. The preshear line is between 18 and 24 inches out of alignment in the horizontal and vertical directions. There are converging and diverging preshear holes that unequally distributed the explosives in the slope (Figure 2). In addition, there appears to be a hard toe developing along the base of the exposed presplit face, possibly indicating that the unequal distribution of the explosives due to poor preshear drilling alignment and the distance of the first buffer production row maybe too far to adequately break up the rock. No back break, overbreak, or face spalling was observed in the fresh presplit face. Overall, we were very disappointed with the preshear line between LW Station 1328+85 and about 1329+25. The preshear section from approximately LW Station 1329+25 to 1329+50 was in much better condition and drill control was substantially improved with closer spaced 3-inch drill holes (Figure 3). From LW Station 1328+85 to 1329+25, the holes were spaced wider than 24 inches and appeared to be 3.5-inch drill holes.

Figure 2. A photo of the poor vertical and horizontal drill control of the preshear line between approximately LW Station 1328+85 and 1329+25.

when the lift got to full depth and would ask for a credit for all the preshear lines out of specification tolerances. I emphasized to Brandon that drill control is a major issue that we need them to get under control in this complex geology. We saw great face conditions when drilling was better controlled under the soil nail wall last year with adverse geology dipping out of the slope. Brandon said that he would continue to emphasize to Brad Collier (Western States Lead Driller) that drilling was very important. I told him that even though we couldn't see much of their preshear drilling that Jerry and I were not totally satisfied with the preshear alignment we just reviewed between LW 1326+00 to 1327+00. Again, I emphasized that drill control was one of the few things that we can control the outcome of on this hill and that we should do everything in our power to make sure we are doing it well. This has been a reoccurring theme with Brandon and Western States this season. From what we have observed thus far, they are making strides to improve their drill control.

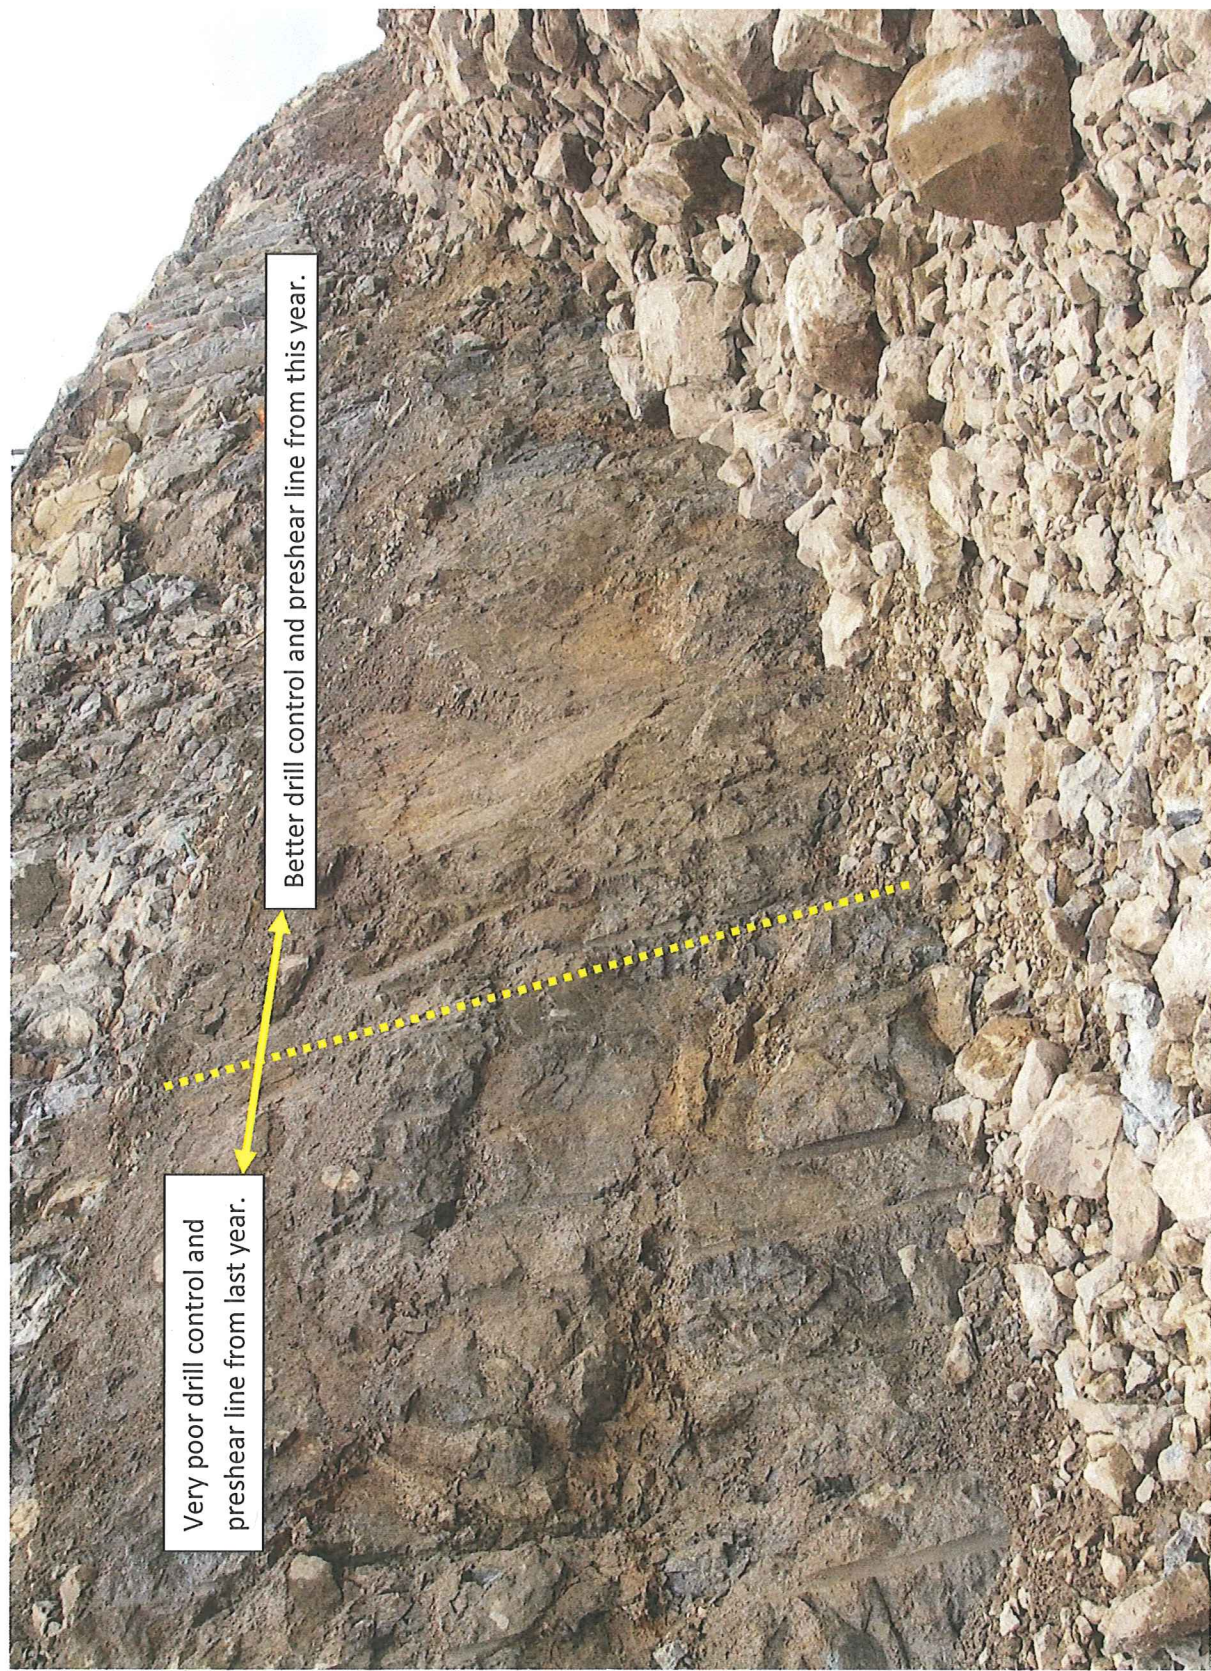
Brandon Bair joined Eric Smith, Mike Mulhern, Brad Schut, Jerry Dilley and I at the face at 1:30 pm. We began talking about the lack of drill control in the preshear and Brandon mentioned that we were looking at old preshear line from last season. He indicated that their first hole this season was drilled at LW Station 1329+27, but he did agree that the preshear line was poor in last years face. Brad told us that he would evaluate the preshear lines

Figure 3. A photo looking at the presplit drilled last year and this year by Western States from approximately LW Station 1329+10 to 1329+50. The older preshear was not exposed and subjected to the winter shutdown weather.
